MAITLAND GAOL Conservation Management Plan PART 2

Final Report

Maitland City Council

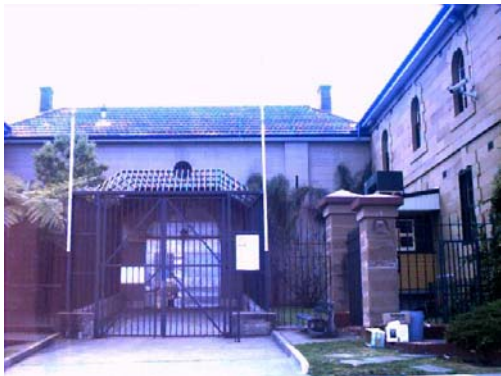
3.01 Gatehouse Central

SITE PLAN NUMBER:	ASSET NUMBER:												
		T	1												
PREVIOUS USE: <ul style="list-style-type: none">Entry	SIGNIFICANCE RATING (from figure 6.1, page 92): <ul style="list-style-type: none">Considerable														
PROPOSED USES: <ul style="list-style-type: none">Service Entry and Toilet facility

ELEMENT	SIGNIFICANCE	RECOMMENDATION
Floors	Considerable, although vinyl finish is of little significance and the concrete topping under the stair is of little significance.	Retain existing floor. Remove vinyl and return to earlier floor is preferred.
Skirtings	Little	Remove skirtings and have none.
Walls	Considerable, except for the enclosures either side of the chimneys, which are of little significance, but for first floor east side, south end which has some significance.	Remove all internal walls and return to original configuration. Retain a rendered finish as stone appears to have been sparrows picked when the render was applied. Retain the existing paint colour or repaint in a stone colour.
Cornices	Little	Existing cornices can be retained but it would be preferable to remove these and reinstate original details. If existing cornices are retained repaint in the existing colour.

Architraves	Little	If original detail of architraves can be determined install to original details. Otherwise install simple rectangular architraves where required and paint in original colours.
Lighting	Intrusive	Replace when ceilings are replaced with something more sympathetic.

PROBLEM	RECOMMENDATION
Access	No access to ground floor due to steps	Ramps will be intrusive to the space therefore use must remain non public.
	No access to first floor	As no access to ground floor then no access needs to be provided to the first floor but use must remain non public.
BCA	No handrail to stairs	Install a handrail
	Nosings not contrasted	As first floor remains non public retain stairs as is.

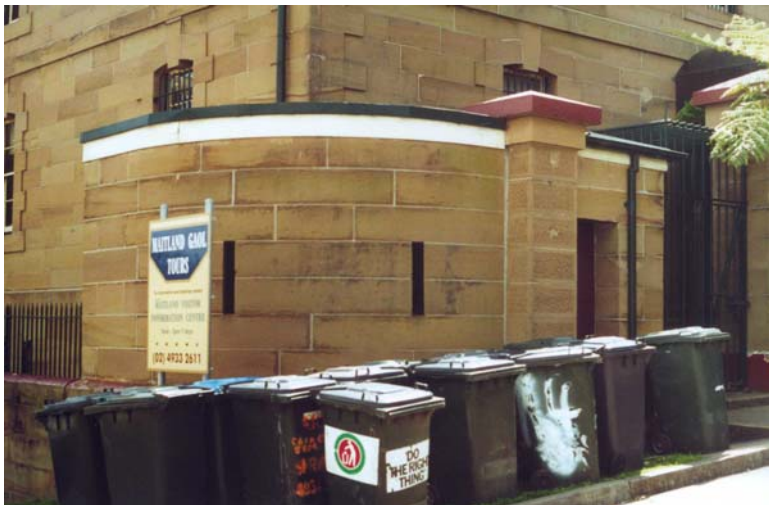
3.04 Sentry Post (Gatehouse)

SITE PLAN NUMBER: Not Provided	ASSET NUMBER: 4
PREVIOUS USE: <ul style="list-style-type: none">Guard Posts	SIGNIFICANCE RATING (from figure 6.1, page 92): <ul style="list-style-type: none">Considerable		
PROPOSED USES: <ul style="list-style-type: none">Not defined.	SIGNIFICANCE OF ELEMENTS: <ul style="list-style-type: none">Not provided in 6.6 page 95		
COMMENTS: No details on page 121.			
EXISTING POLICIES: None stated on page 121.

ELEMENT	SIGNIFICANCE	RECOMMENDATION
Floor	Considerable, except vinyl which is of little significance	Return floor to original floor under the vinyl.
Walls	Considerable.	Repainting possible in original colours.
Ceiling	Little	Retain existing FC ceiling, however, investigate the original ceiling and if details exist about it reinstate original details.
Windows	Some significance to the small windows and little significance to the larger window.	Retain existing unless the original details of the windows can be found, when reconstruction to the original details is preferred.
Door	Considerable.	Retain and repaint in existing or original colours.

PROBLEM	RECOMMENDATION
Access	A step exists at entry and is therefore not accessible.	As room can be appreciated from the doorway, no ramp is required.
	Door is too narrow for access requirements.	As room can be appreciated from the doorway, no change is required.

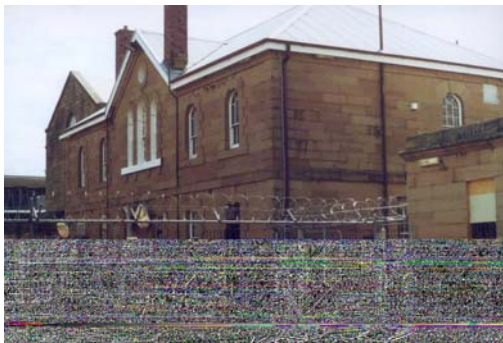
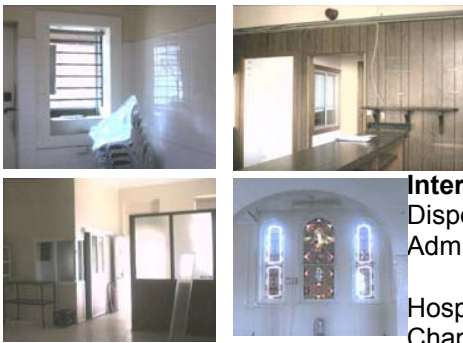
3.05 Internal Administration

</div></div><div><div><div>Interiors:</div><div>Dispensary (Top Left)</div><div>Administration Area (Top Right)</div><div>Hospital (Bottom Left)</div><div>Chapel (Bottom Right)</div></div><div><div>

</div></div></div></div></div>	<div><div>SITE PLAN NUMBER:</div><div>F</div></div>	<div><div>ASSET NUMBER:</div><div>5</div></div>																						
<div><div>PREVIOUS USE:</div><div><ul style="list-style-type: none">Chapel, Offices, Hospital</div></div>	<div><div>SIGNIFICANCE RATING (from figure 6.1, page 92):</div><div><ul style="list-style-type: none">Considerable</div></div>																							
<div><div>PROPOSED USES:</div><div><ul style="list-style-type: none">InterpretationRetailArt Gallery</div></div>	<div><div>SIGNIFICANCE OF ELEMENTS: (from 6.6 page 95)</div><div>

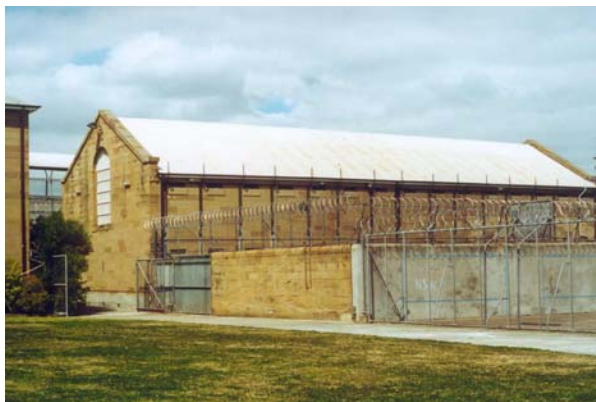
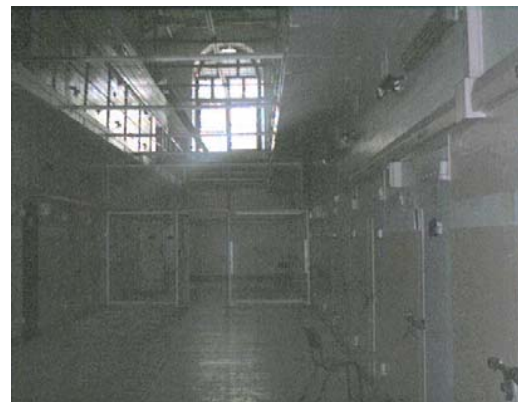
ELEMENT	SIGNIFICANCE	RECOMMENDATION
Floors	Some significance, East store of little significance.	Retain painted concrete. Repainting is possible, but must be in existing colours eg beige to the beige area only. Unpainted section near control post to remain unpainted. Retain existing vinyl in the East storeroom or remove it back to bare concrete. The West storeroom floor to be repainted in green when essential.
Skirtings	Some significance	Retain existing painted skirting. Repainting in existing colours for maintenance purposes is possible.
Walls	Considerable, except:	Retain existing walls as they are. Minimal patch repainting of areas where walls have deteriorated (i.e. where paint has flaked off at ground level) in existing colours can be undertaken.

PROBLEM	RECOMMENDATION
Access	Ramp is at 1 to 10 and too steep.	Reconstruct at 1 in 14.
	No kerb or hand rails to ramp.	Install hand and kerb rails.
	Doors are heavy.	Leave doors open when building is available for access.
	No access to upper floors for wheelchairs.	No action as the space can be appreciated from ground floor. The cells are the same on upper levels as the ground floor and the walkways on the upper floors are too narrow for access by wheelchairs. There is no major need or requirement to access the upper levels.
	Stairs have no contrasting nosing.	Do nothing for the same reasons as above.
	Handrail to stairs is too high at 1m.	No action. Same reasons as above.
Egress	4 exits exist although the 3 to the West and East sides are 610 mm wide.	Retain all existing exits and seek dispensation for reduced width.

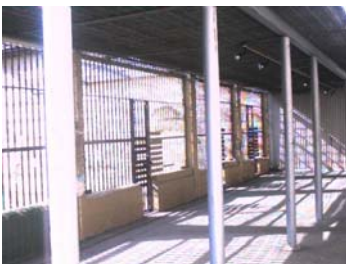
ELEMENT	SIGNIFICANCE	RECOMMENDATION
Floors	Some significance	Retain as is.
Walls	Some significance	Retain as is. Original finish appears to be sandstone and the removal of the paint may occur by natural or artificial means. Repainting of the walls should not happen.
Ceilings	Some significance	Retain existing. Repainting in existing colours to preserve the metal.
Gates	Some significance	Retain. Repaint in original colours as required to preserve them.
Fittings	Some significance	Retain existing fittings.
Cover over the yard between G and H	Little	Remove cover unless considered essential for proposed future use.

<i>PROBLEM</i>	<i>RECOMMENDATION</i>
Access	Gates into yards only 550mm wide. Dishdrain along yards.	Leave as is as yards can be appreciated from outside.

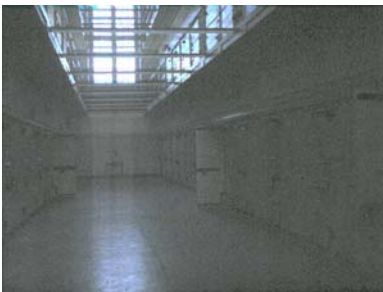
ELEMENT	SIGNIFICANCE	RECOMMENDATION
Floors	Some significance	Retain painted concrete. Repainting is possible, but must be the existing green colour. Retain existing vinyl in dentist's room.
Skirtings	Some significance	Retain existing painted skirting. Repainting in existing colour for maintenance purposes is possible. Retain existing skirtings in dentist's room. Repaint in existing colours as required for essential maintenance.

PROBLEM	RECOMMENDATION
Access	Ramp is at 1 to 12 and too steep.	Reconstruct at 1 in 14.
	No kerb at side of ramp.	Add a kerb rail between balusters.
	Handrail is too high.	Install handrail at correct height.
	Doors are heavy.	Leave doors open when building is available for access.
	No access to upper floors for wheelchairs.	No action as the space can be appreciated from ground floor. The cells are the same on upper levels as the ground floors and the walkways are too narrow. There is no major need or requirement to access the upper levels.
	Stairs have no contrasting nosing.	Do nothing for the same reasons as above.
	Handrail to stairs is too high at 1100 mm.	No action. Same reasons as above.
	No handrail to dentist.	Install handrail.

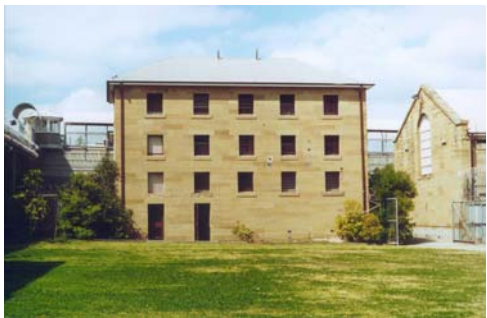
3.13 Kitchen

SITE PLAN NUMBER: I	ASSET NUMBER: 13										
PREVIOUS USE: <ul style="list-style-type: none">Preparation of Meals with Gaol cells and recreation above.				SIGNIFICANCE RATING (from figure 6.1, page 92): <ul style="list-style-type: none">Some													
PROPOSED USES: <ul style="list-style-type: none">InterpretationFood Packaging and processingSmall group training and overnight accommodation.				SIGNIFICANCE OF ELEMENTS (from 6.6 page 96):

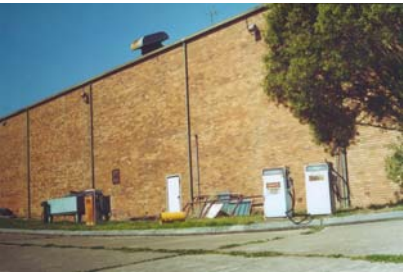
3.14 Building A Store

SITE PLAN NUMBER: A	ASSET NUMBER: 14
PREVIOUS USE: <ul style="list-style-type: none">• Storage• Laundry• Shower facility• Leather shop• Theatrette	SIGNIFICANCE RATING (from figure 6.1, page 92): <ul style="list-style-type: none">• Little			
PROPOSED USES: <ul style="list-style-type: none">• Small events, drama and functions• Music events (e.g. Jazz, Country)• Mobile retail (i.e. markets)• Retail incorporating interpretation and storage	SIGNIFICANCE OF ELEMENTS: (from 6.6 page 96) <ul style="list-style-type: none">• Machinery and other loose equipment items• Fitout for offices, storage etc.		C	D/I
COMMENTS (from page 136): Constructed c1970 at a time of expansion of the gaol.				
EXISTING POLICIES: (from page 136) 7.8.1 Find a use for the Store within its current envelope. This use could be associated with the future use of the Gaol, or be quite distinct.

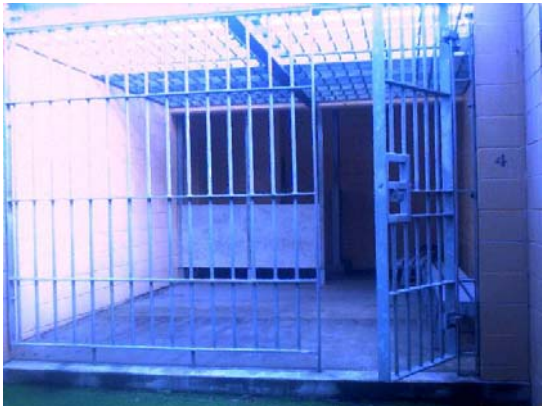
3.17 Exercise Cells

SITE PLAN NUMBER: O	ASSET NUMBER: 17
PREVIOUS USE: <ul style="list-style-type: none">Exercise area	SIGNIFICANCE RATING (from figure 6.1, page 92): <ul style="list-style-type: none">Little		
PROPOSED USES: <ul style="list-style-type: none">Small seminars and overnight camping.	SIGNIFICANCE OF ELEMENTS: (from 6.6 page 97) <ul style="list-style-type: none">Not stated as it is a recent addition in context of gaol evolution		
COMMENTS (from page 129): Constructed during 1991 upgrade.			
EXISTING POLICIES: None defined in page 129 – 130.

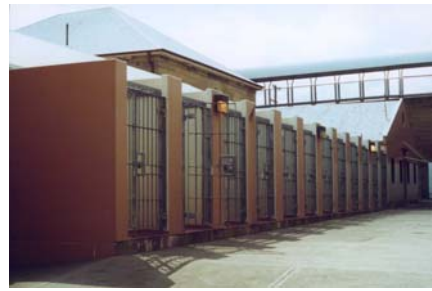
3.18 Maximum Security

SITE PLAN NUMBER: K	ASSET NUMBER: 18
PREVIOUS USE: <ul style="list-style-type: none">Control roomGaol cells.	SIGNIFICANCE RATING (from figure 6.1, page 92): <ul style="list-style-type: none">Little				
PROPOSED USES: <ul style="list-style-type: none">Small SeminarsOvernight Camping	SIGNIFICANCE OF ELEMENTS: <ul style="list-style-type: none">No statement in 6.6 as it is a recent addition in the context of Gaol evolution.				
COMMENTS (from pages 129 – 130): Constructed as part of the 1991 upgrade.					
EXISTING POLICIES (from page 130): 7.6.30 Retain the overall footprint of the cell block and its relationship to ‘4-wing’. Substantial alteration to the internal layout would be acceptable if an example of typical cells is retained unaltered, for example, if cells 1 and 2 (and yards) are retained unaltered.

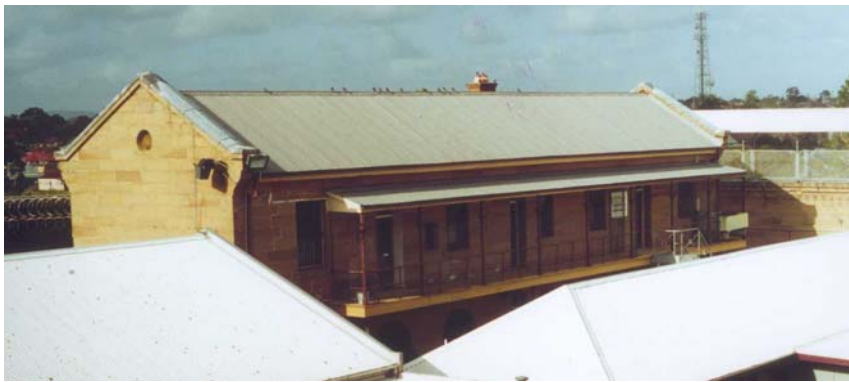
3.19 Building N Maintenance Block

SITE PLAN NUMBER: N	ASSET NUMBER: 19																				
PREVIOUS USE: <ul style="list-style-type: none">• Gym• Computer room• General purpose building	SIGNIFICANCE RATING (from figure 6.1, page 92): <ul style="list-style-type: none">• Considerable																							
PROPOSED USES: <ul style="list-style-type: none">• Interpretation• Mobile retail

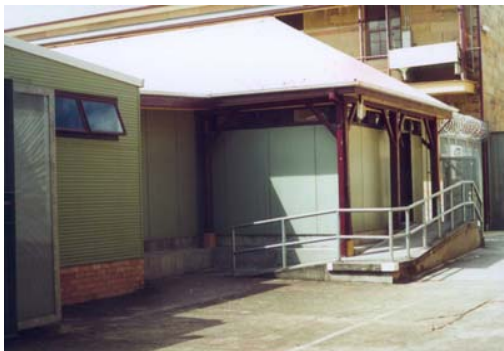
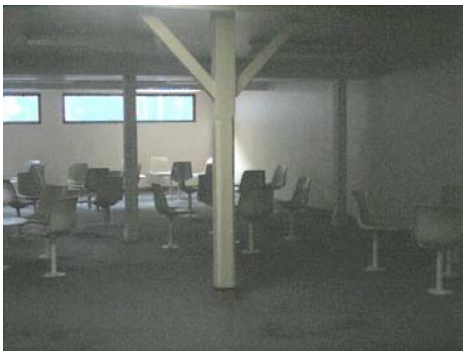
3.20 Visitors' Centre

SITE PLAN NUMBER: L	ASSET NUMBER: 20										
PREVIOUS USE: <ul style="list-style-type: none">Offices, Visitor Meeting Areas		SIGNIFICANCE RATING (from figure 6.1, page 92): <ul style="list-style-type: none">Considerable for the original stone cutter's shelter shed and little for the new building.													
PROPOSED USES: <ul style="list-style-type: none">InterpretationMerchandising (retail / artisans display)Functions or Small Group Seminars

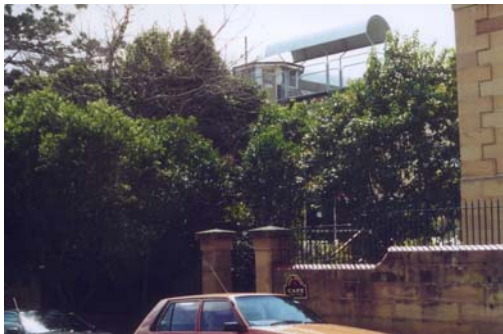
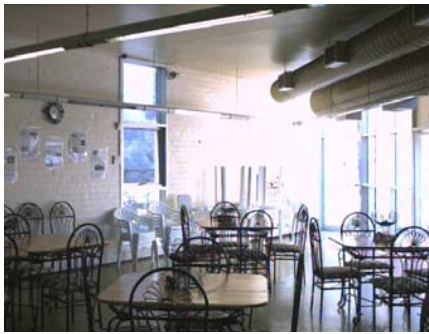
3.22 Officers' Amenities

SITE PLAN NUMBER: B	ASSET NUMBER: 22
PREVIOUS USE: <ul style="list-style-type: none">• Café• Squash Centre		SIGNIFICANCE RATING (from figure 6.1, page 92): <ul style="list-style-type: none">• Little		
PROPOSED USES: <ul style="list-style-type: none">• Café• Video Presentation		SIGNIFICANCE OF ELEMENTS (from 6.6 page 97): <ul style="list-style-type: none">• Recent Addition <div>D/I</div>		
COMMENTS: (from page 137) <p>Part of the evolution of the gaol but conceals original gaol wall and has a detrimental affect on Asset 2.</p>				
EXISTING POLICIES: <p>None provided under 7.8 page 137</p>

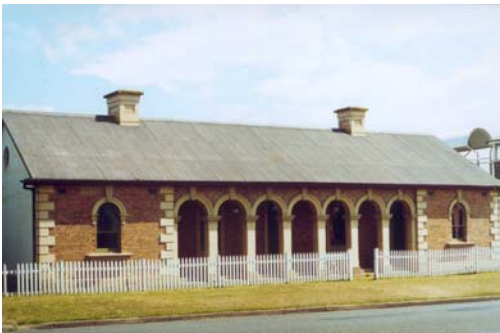
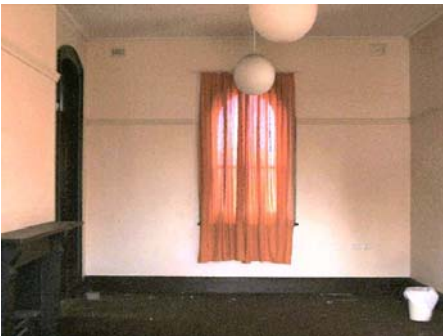
3.26 Barracks

SITE PLAN NUMBER: P	ASSET NUMBER: 26
PREVIOUS USE: <ul style="list-style-type: none">No usage in recent time		SIGNIFICANCE RATING (from figure 6.1, page 92): <ul style="list-style-type: none">Considerable		
PROPOSED USES: <ul style="list-style-type: none">Art and Craft displays and retailInterpretationTraining rooms		SIGNIFICANCE OF ELEMENTS: <ul style="list-style-type: none">Not defined in 6.6, page 97		
COMMENTS (from page 135): Largely unmodified except timber shingles and some ceilings replaced.				
EXISTING POLICIES (from page 133 and 134): 7.7.3 A compatible new use for the former Mounted Police Barracks should be sought and it should be conserved as a significant element of the Barracks group. 7.7.4 The Barracks building should be restored, and introduction of modern elements restricted.

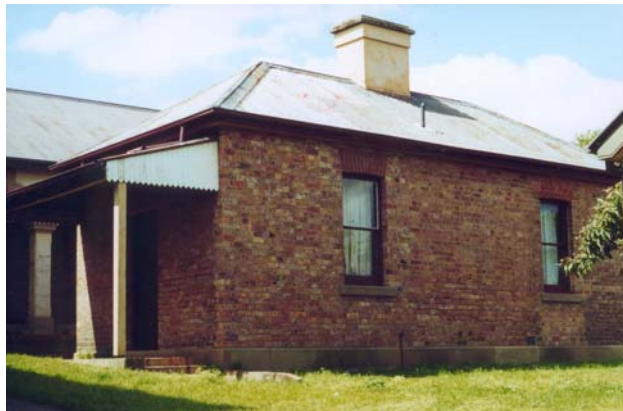
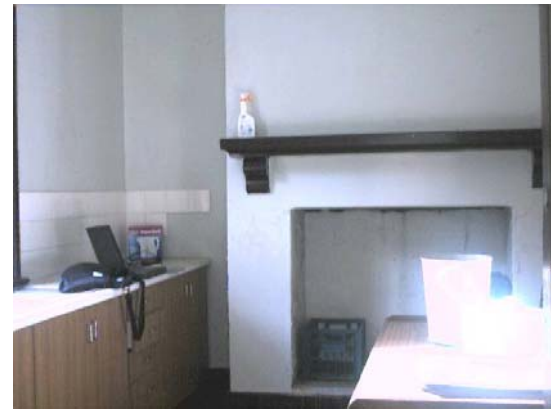
3.27 Barracks Kitchen Block

SITE PLAN NUMBER: Q	ASSET NUMBER: 27
PREVIOUS USE: <ul style="list-style-type: none">No usage in recent time	SIGNIFICANCE RATING (from figure 6.1, page 92): <ul style="list-style-type: none">Considerable			
PROPOSED USES: <ul style="list-style-type: none">Undefined	SIGNIFICANCE OF ELEMENTS: <ul style="list-style-type: none">Not defined in 6.6, page 97			
COMMENTS (from page 134): Once located in a walled enclosure with the toilets.				
EXISTING POLICIES (from page 134): 7.7.5 The Former Barracks Kitchen should be retained and conserved as a significant element of the Barracks group.

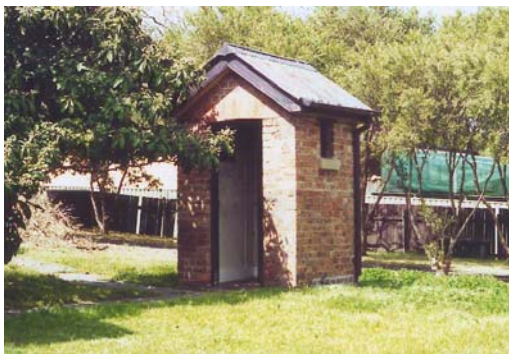
3.28 Police Toilets

SITE PLAN NUMBER:	ASSET NUMBER:
		-	28
PREVIOUS USE: <ul style="list-style-type: none">• Toilet	SIGNIFICANCE RATING (from figure 6.1, page 92): <ul style="list-style-type: none">• Some		
PROPOSED USES: <ul style="list-style-type: none">• No proposed use	SIGNIFICANCE OF ELEMENTS (from figure 6.6 page 98): <ul style="list-style-type: none">• No details provided		
COMMENTS (from page 134): Original wall removed but toilets are intact			
EXISTING POLICIES (from page 134): 7.7.6 Conserve as part of the barracks group

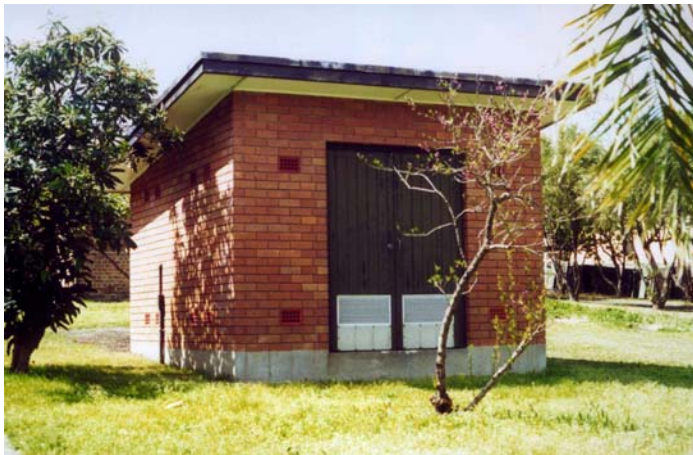
3.29 Compressor Building

R	29
PREVIOUS USE: <ul style="list-style-type: none">No usage in recent times.	SIGNIFICANCE RATING (from figure 6.1, page 92): <ul style="list-style-type: none">Intrusive		
PROPOSED USES: <ul style="list-style-type: none">No proposed use.	SIGNIFICANCE OF ELEMENTS: (from 6.6 page 98) <ul style="list-style-type: none">Not original, intrusive in this context		
COMMENTS: (from page 134) Constructed c1977			
EXISTING POLICIES: (from page 134) 7.7.7 The building may be demolished in the context of improving the setting of the former Police Barracks complex.

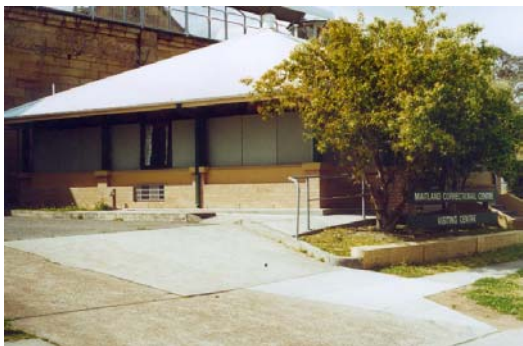
3.36 Visitors Administration Centre

SITE PLAN NUMBER: M	ASSET NUMBER: 36
PREVIOUS USE: <ul style="list-style-type: none">Administration; Visitor Access		SIGNIFICANCE RATING (from figure 6.1, page 92): <ul style="list-style-type: none">Little		
PROPOSED USES: <ul style="list-style-type: none">Ticketing and AdministrationCommercial		SIGNIFICANCE OF ELEMENTS: <ul style="list-style-type: none">Not defined in 6.6, page 98		
COMMENTS (from page 137): Part of the major upgrade in 1991				
EXISTING POLICIES (from page 137): 7.8.2 The Visitors Centre if retained should be used (possibly as a secondary point of access to the site) in association with the new use and interpretation of the Gaol.

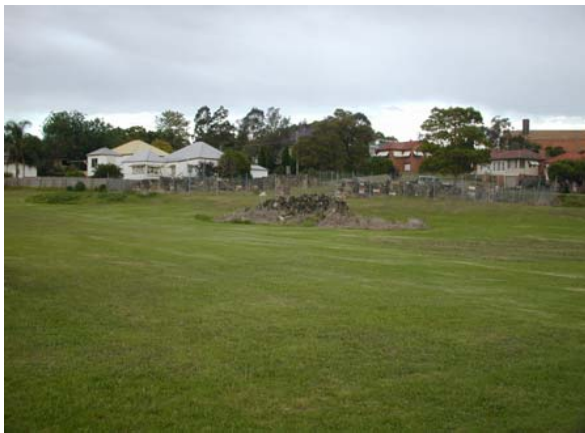
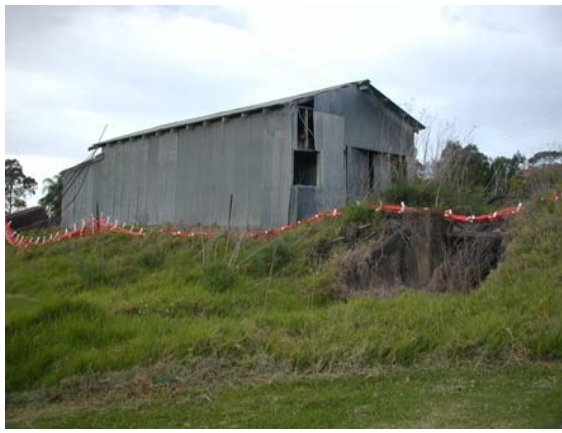
4.3 Prison Farm

PREVIOUS USE: <ul style="list-style-type: none">Prison Farm	SIGNIFICANCE RATING (from figure 6.5, page 93): <ul style="list-style-type: none">Some significance		
PROPOSED USES: <ul style="list-style-type: none">Grazing / Fallow land	SIGNIFICANCE of ELEMENTS (from figure 6.6): <ul style="list-style-type: none">Not defined		
COMMENTS (from Section 7): Not provided.			
EXISTING POLICIES (from Section 7): Not provided
